# NATIONAL CERTIFIED TESTING LABORATORIES

**NCTL Report No:** 210-3198-1

**Tests Conducted:** Dade County Building Code Compliance Office Protocol TAS 201-94, Impact Test Procedures. Dade County Building Code Compliance Office, TAS 202-94, "Criteria for Testing Impact and Non-Impact Resistant Building Envelope Components using Uniform Static Air Pressure." Dade County Building Code Compliance Office TAS 203-94, "Criteria for Testing Products Subjected To Cyclic Pressure Loading."

**Model Designation** - 25 mm Hurricane Storm Panel R.D.C.

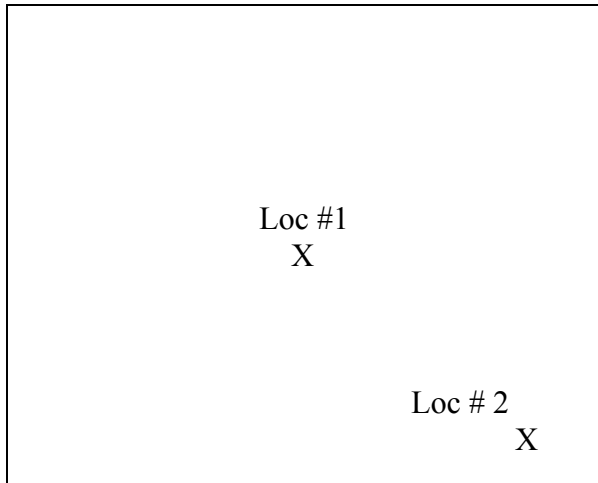
**Specimen # 2**

**Location # 1:** Center of Panel.  
Deflection at Impact measured 1.625"  
**Location # 2:** Bottom Right Corner of Panel. Deflection at Impact measured 1.250"

Description of specimens after impact test: *There was no penetration*

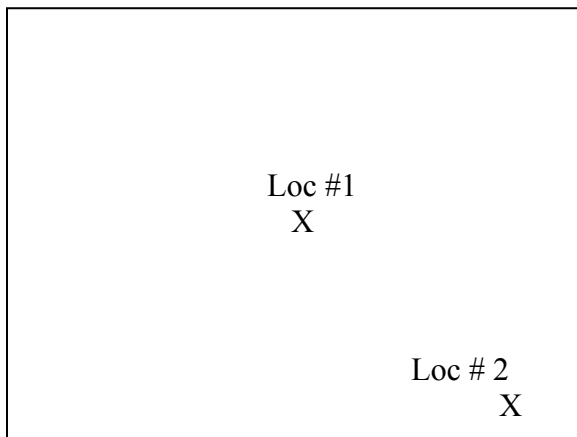
**Specimen # 3**

Description of specimens after impact test: *There was no penetration*

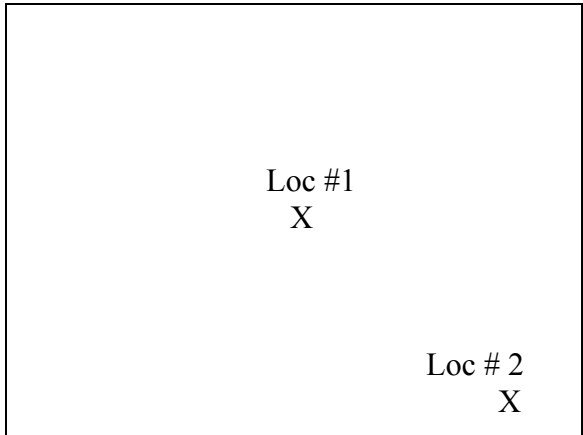
**Specimen # 4**

**Location # 1:** Center of Panel. Deflection at Impact measured 1.500”  
**Location # 2:** Bottom Right Corner of Panel. Deflection at Impact measured 1.125”

Description of specimens after impact test: There was no penetration
