# NATIONAL CERTIFIED TESTING LABORATORIES

**NCTL Report No:** 210-3193-1

**Tests Conducted:** Dade County Building Code Compliance Office Protocol TAS 201-94, Impact Test Procedures. Dade County Building Code Compliance Office, TAS 202-94, "Criteria for Testing Impact and Non-Impact Resistant Building Envelope Components using Uniform Static Air Pressure." Dade County Building Code Compliance Office TAS 203-94, "Criteria for Testing Products Subjected To Cyclic Pressure Loading."

**Model Designation** - 0.280" (7mm) Corrugated Onda Plus Storm Panel

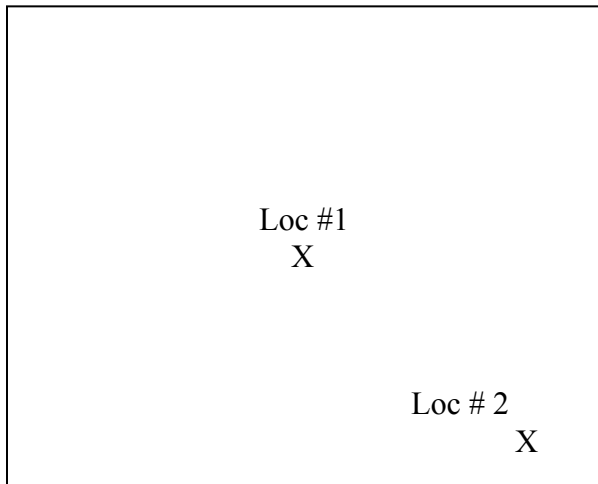
**Specimen # 2**

**Location # 1:** Center of Panel. Deflection at Impact measured 1.125"  
**Location # 2:** Bottom Right Corner of Panel. Deflection at Impact measured 0.875"

Description of specimens after impact test: *There was no penetration.*

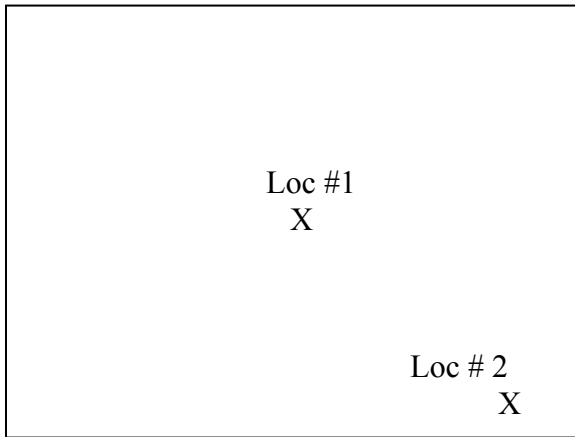
**Specimen # 3**

Description of specimens after impact test: *There was no penetration*

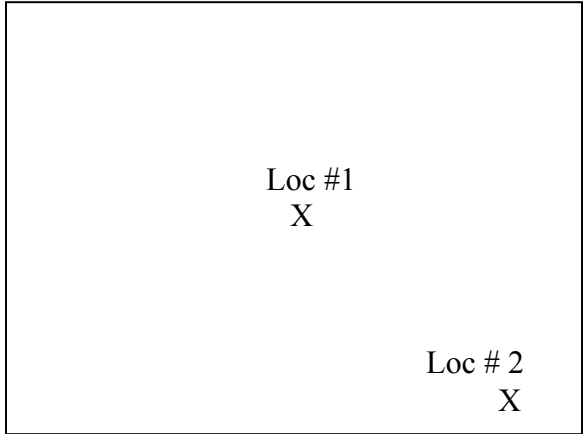
**Specimen # 4**

**Location # 1:** Center of Panel. Deflection at Impact measured 1.00”  
**Location # 2:** Bottom Right Corner of Panel. Deflection at Impact measured 0.9375”

Description of specimens after impact test: There was no penetration
