NATIONAL CERTIFIED TESTING LABORATORIES

NCTL Report No: 210-3198-1

Tests Conducted: Dade County Building Code Compliance Office Protocol TAS 201-94, Impact Test Procedures. Dade County Building Code Compliance Office, TAS 202-94, "Criteria for Testing Impact and Non-Impact Resistant Building Envelope Components using Uniform Static Air Pressure." Dade County Building Code Compliance Office TAS 203-94, "Criteria for Testing Products Subjected To Cyclic Pressure Loading."

Model Designation - 25 mm Hurricane Storm Panel R.D.C.

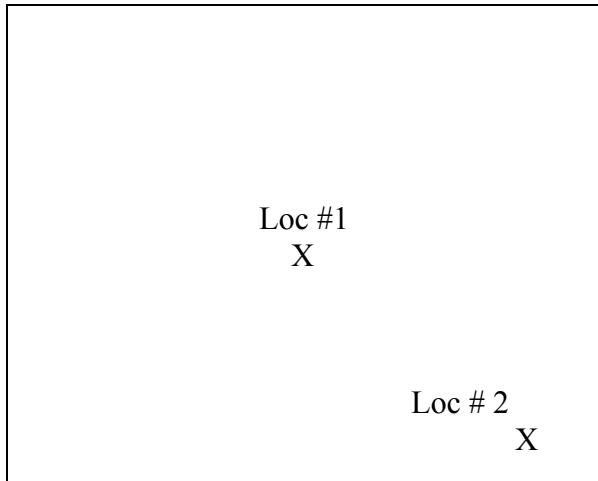
Specimen # 2

Location # 1: Center of Panel.
Deflection at Impact measured 1.625"
Location # 2: Bottom Right Corner of Panel. Deflection at Impact measured 1.250"

Description of specimens after impact test: *There was no penetration*
