NATIONAL CERTIFIED TESTING LABORATORIES

NCTL Report No: 210-3193-1

Tests Conducted: Dade County Building Code Compliance Office Protocol TAS 201-94, Impact Test Procedures. Dade County Building Code Compliance Office, TAS 202-94, "Criteria for Testing Impact and Non-Impact Resistant Building Envelope Components using Uniform Static Air Pressure." Dade County Building Code Compliance Office TAS 203-94, "Criteria for Testing Products Subjected To Cyclic Pressure Loading."

Model Designation - 0.280" (7mm) Corrugated Onda Plus Storm Panel

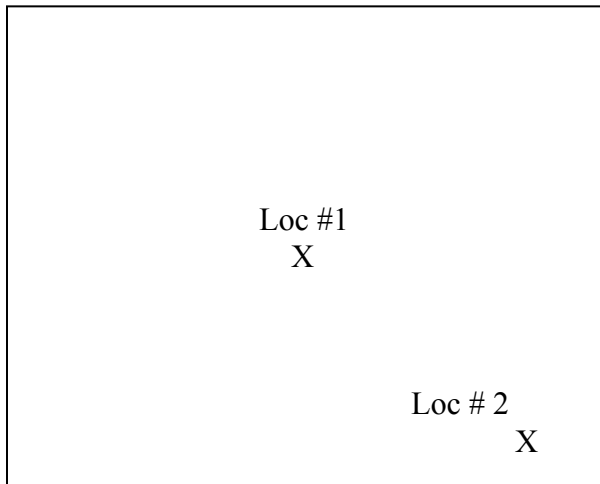
Specimen # 2

Location # 1: Center of Panel. Deflection at Impact measured 1.125"
Location # 2: Bottom Right Corner of Panel. Deflection at Impact measured 0.875"

Description of specimens after impact test: *There was no penetration.*

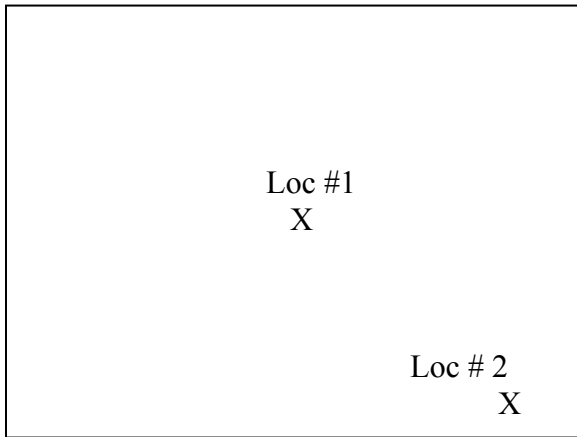
Specimen # 3

Description of specimens after impact test: *There was no penetration*

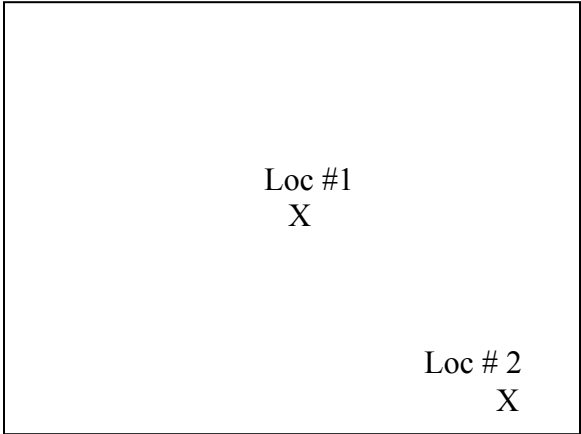
Specimen # 4

Location # 1: Center of Panel. Deflection at Impact measured 1.00”
Location # 2: Bottom Right Corner of Panel. Deflection at Impact measured 0.9375”

Description of specimens after impact test: There was no penetration
