# NATIONAL CERTIFIED TESTING LABORATORIES

NCTL Report No.: 210-3198-1  
Test Date: 08/30/05  
Report Date: 09/08/05

**Tests Conducted:** Dade County Building Code Compliance Office Protocol TAS 201-94, Impact Test Procedures. Dade County Building Code Compliance Office, TAS 202-94, "Criteria for Testing Impact and Non-Impact Resistant Building Envelope Components using Uniform Static Air Pressure." Dade County Building Code Compliance Office TAS 203-94, "Criteria for Testing Products Subjected To Cyclic Pressure Loading."

**Model Designation** - 25 mm Hurricane Storm Panel R.D.C.

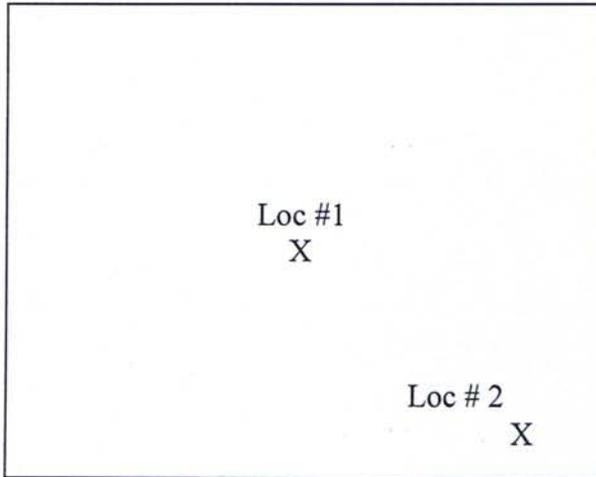
**Specimen # 2**

*Location # 1: Center of Panel.*

*Location # 2: Bottom Right Corner of Panel.*

Description of specimens after impact test: *There was no penetration*

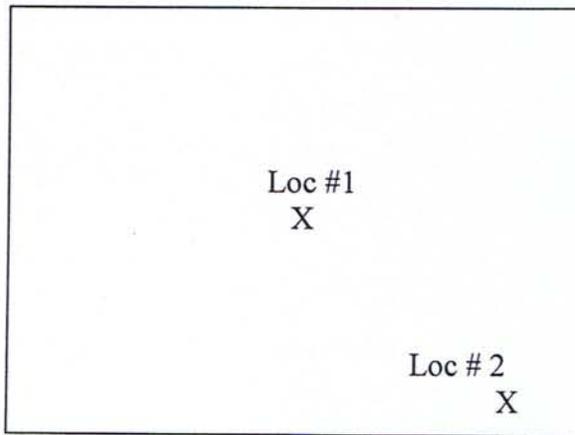
**Specimen # 3**

*Location # 1: Center of Panel.*

*Location # 2: Bottom Right Corner of Panel*

Description of specimens after impact test: *There was no penetration*

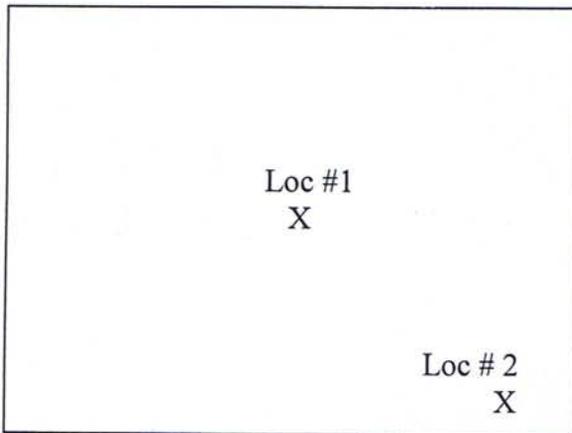
**Specimen # 4**

Location # 1: Center of Active Sash  
Location # 2 Bottom Right Corner of Panel

Description of specimens after impact test: There was no penetration
